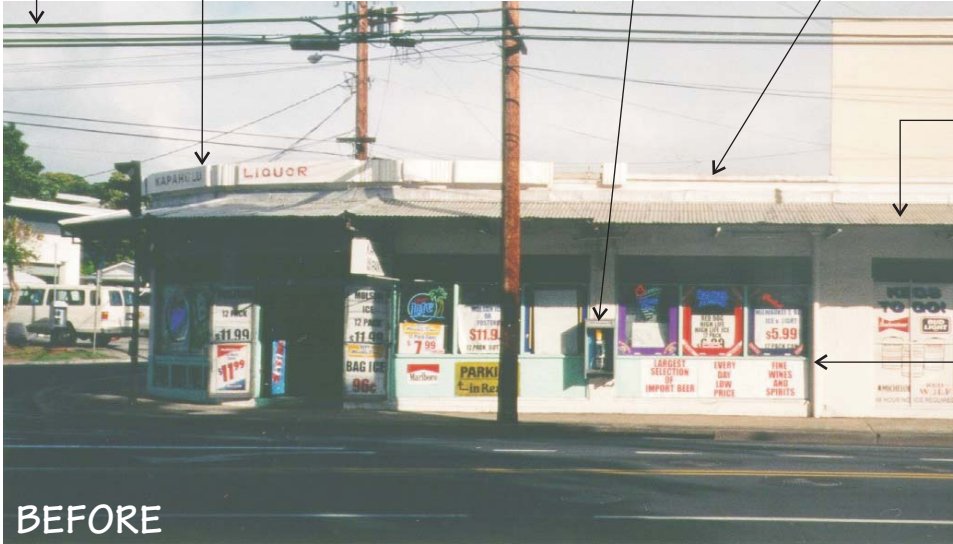
Overhead wires create visual clutter

The Kapahulu Liquor sign disrupts the roof parapet and is out of proportion with the building facade

The public pay phone adds clutter to the building facade

The roof parapet is discontinuous and undefined

The canopy, although a desirable feature, is in need of repair

The clutter of window display signs is unattractive and does little to attract customers

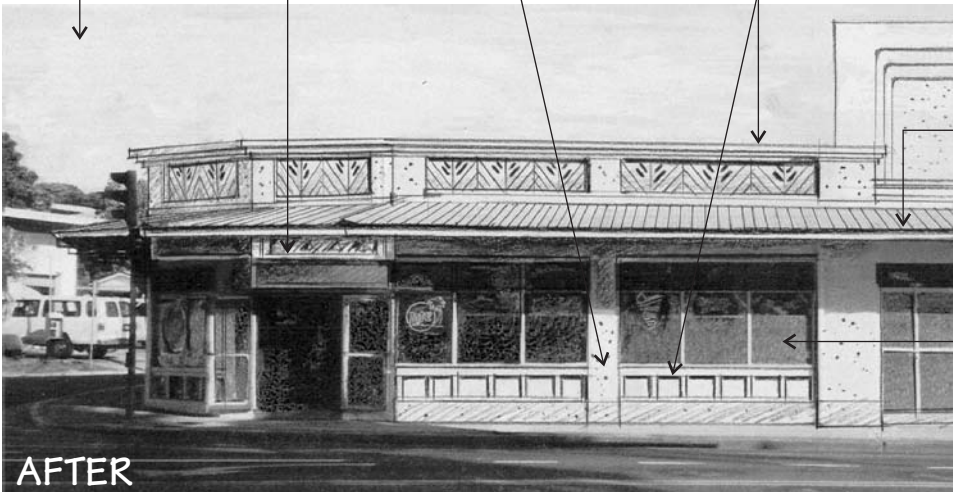
Overhead wires have been buried underground

Aesthetically graphic and dimensional signage has been added

The public pay phone has been removed from the building facade

The addition of a bold roof parapet and repeating panels under the display windows complements the horizontal feature of existing buildings in Kapahulu

The canopy, which is both decorative and functional, is repaired and maintained

The City's existing sign regulations are enforced and advertising of "low prices" no longer blocks the display windows
