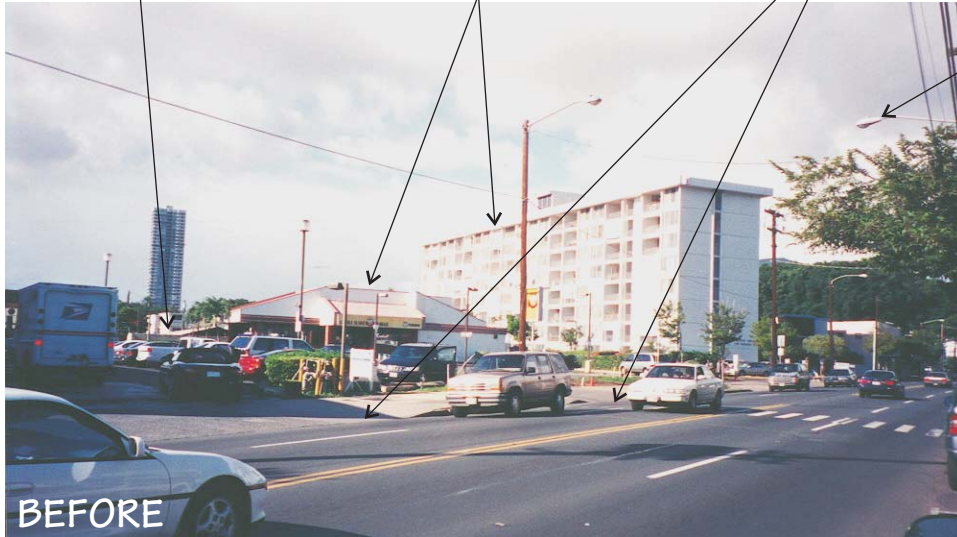
BEFORE

Parking fronting Kapahulu Avenue creates an unattractive, auto-oriented streetscape

The disparity in building height and scale is visually disruptive and conflicts with Kapahulu's historic storefront design

Numerous driveways disrupt vehicular and pedestrian traffic

Street lights address vehicles instead of pedestrians

The lack of street trees creates a harsh environment

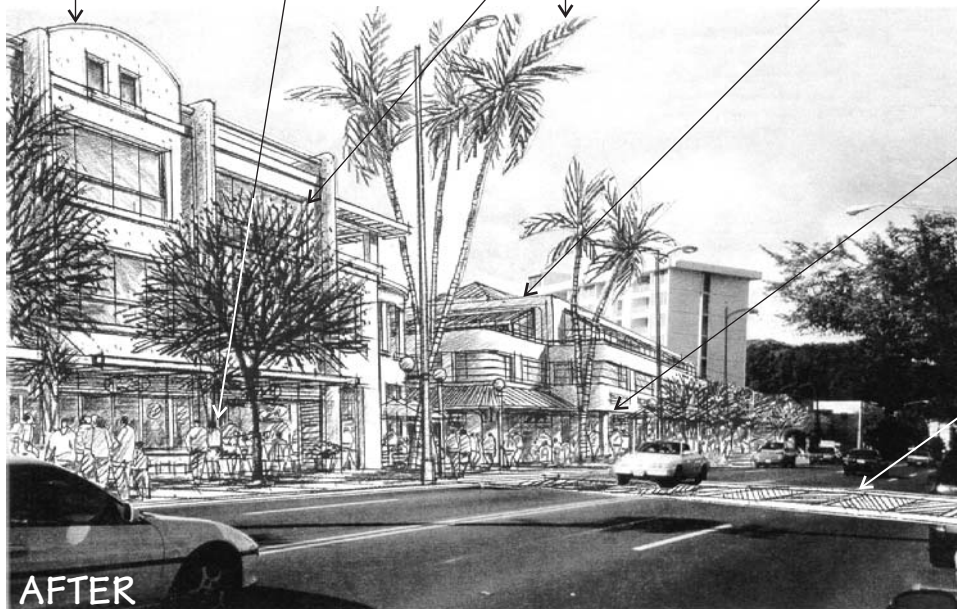
AFTER

Contemporary interpretation of Kapahulu's art deco style

Sidewalk seating and dining adds enlivens the streetscape

The addition of street trees enhance the pedestrian experience and soften the streetscape

3-story buildings, up to 40 feet high, along Kapahulu Avenue with residential above ground floor commercial

Canopies and arcades are consistent with Kapahulu's older commercial buildings

The crosswalk has been raised and a textured pavement installed to cue motorists to drive slowly and be aware of pedestrians crossing the street
